Technical Bulletin

Bulletin No: TCH-001-047

Subject: INLET CHECK VALVE REMOVAL

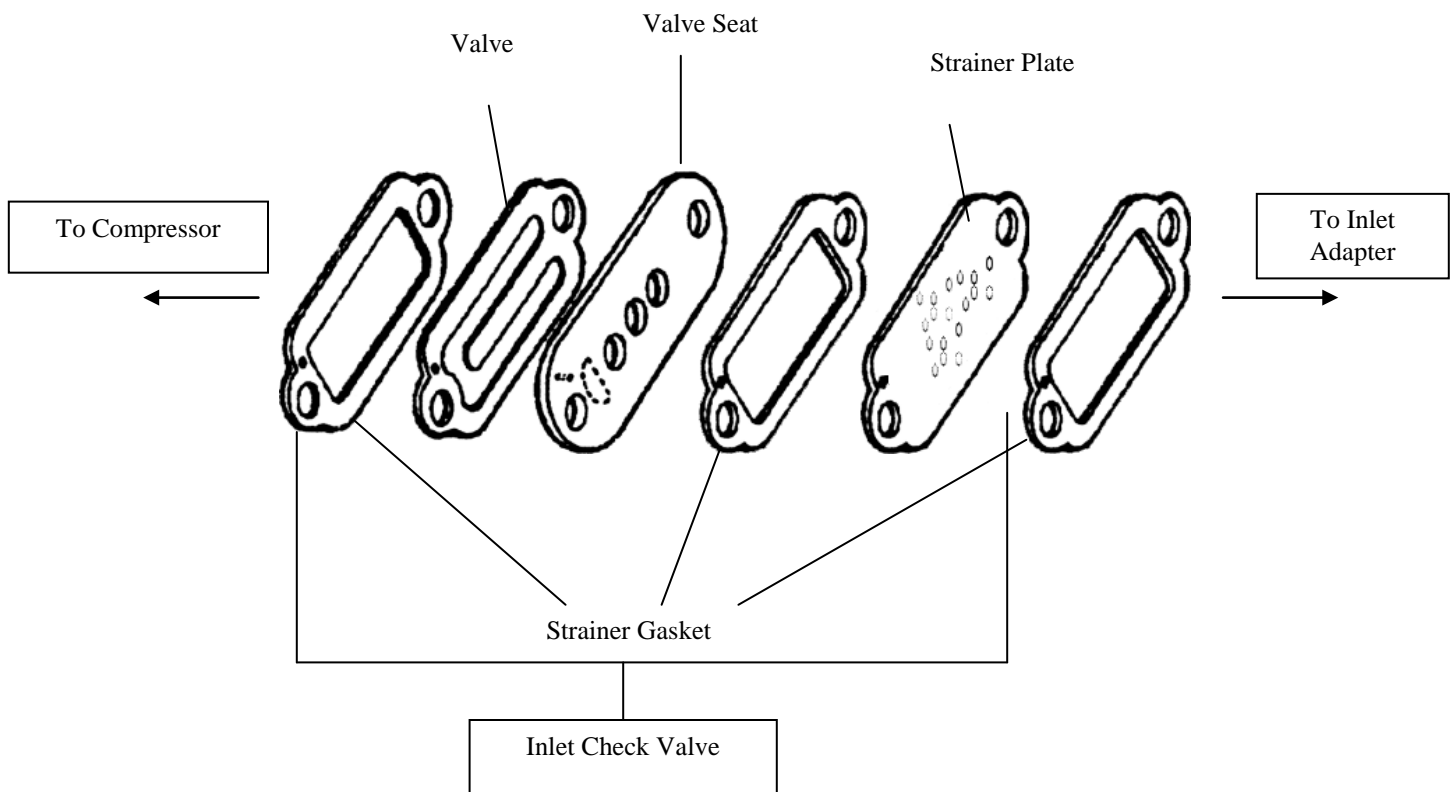
In a joint study conducted by Bendix and International it was determined that compressor oil passing was greatly reduced on some applications when the Inlet Check Valve (ICV) was removed. The applications tested were International engines with the Bendix Tu-Flo 550 or Tu-Flo 750 Compressors and an ICV. It was determined that this application creates a high vacuum on the inlet side of the compressor, resulting in excessive compressor oil passing.

It is recommended that if a compressor is experiencing excessive oil passing, and meets the application criteria above, that the inlet check valve be removed and the inlet adapter be re-installed with new mounting hardware. The illustration below identifies the components that make up the inlet check valve.

Before returning the vehicle to service, thoroughly drain all air reservoirs and clean and service the AD-9 or AD-IP Air Dryer thoroughly. If the excessive oil passing still persists refer to the Bendix Troubleshooting Compressor Oil Passing guide BW1971 prior to the removal of the compressor for replacement.
