# Technical Bulletin

Bulletin No: TCH-002-010

## Subject: **Retrofitting Wide-Based Tires: Increased Vibration Requires Improved Air Chamber Bracket Supports**

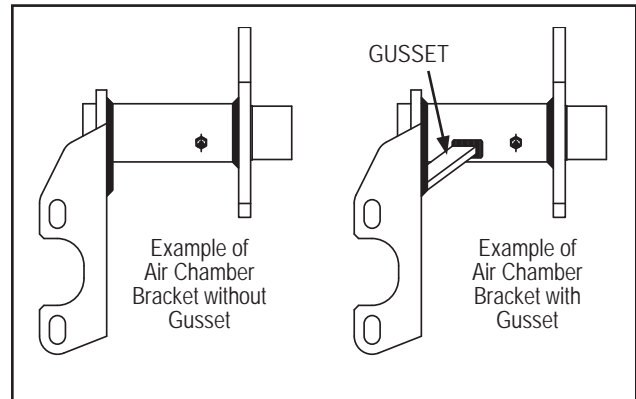
**FIGURE 1 - EXAMPLES OF AIR CHAMBER BRACKETS WITH AND WITHOUT GUSSETS**

Test data has shown that retrofitting “wide-based” tires can result in higher vibrational loading of vehicle drive axles and wheel ends. As a result, the air chamber bracket supports are potentially exposed to vibrations and stresses beyond their original design capabilities.

- Air chamber brackets with gussets (see Figure 1). If the air chamber brackets **do not** have gussets, they must be replaced with Bendix approved air chamber brackets **with** gussets. Identify the part number stamped into the support arm (see Figure 2 for location) and refer to BW7253 for the proper gusseted replacement.
- Bendix “Marion” air chamber bracket supports or other Bendix approved air chamber bracket supports, welded to the axle, are required (see Figure 2).
