# Technical Bulletin

Bulletin No: TCH-003-042

## Subject: BRAKE VALVE TREADLE REPLACEMENT – COACH APPLICATIONS

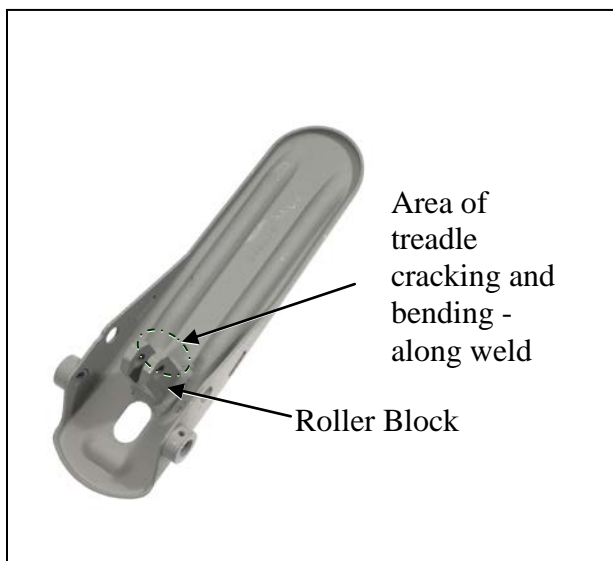
Figure 1 – Old Style Treadle

During normal use, some brake valve treadles may develop small cracks along the top surface, causing the brake valve treadle to bend. Over time this bend will result in a decreased treadle angle, which in turn will require an increase in braking effort by the vehicle operator. A quick visual inspection can identify if this condition is present.

A bump or worn spot present in the treadle cover, near the roller area, may indicate that the treadle is cracked and bent, pushing the cover up in the center. Removal of the treadle cover or inspection of the bottom side of the treadle will verify if this condition exists.

This condition is limited to coach applications with a treadle configuration as shown in Figure 1. This unique treadle has a roller block welded to the middle of its underside. The cracking occurs near this weld.
