Technical Bulletin

Bulletin No: TCH-001-066

Subject: **BENDIX® BA-921® COMPRESSOR INLET FITTING INSTALLATION**

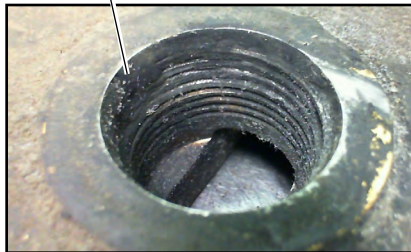
WORN AND DAMAGED
THREADS

INLET PORT THREADS ARE DAMAGED

If the jam nut is not properly positioned prior to installation, the thread engagement of the inlet fitting will be minimized. Normal road vibrations can cause this fitting to move back and forth, resulting in extensive damage to the cylinder head inlet port.

Inspect the inlet fitting for proper positioning of the jam nut and sealing washer and, if necessary, correct their position. Make certain that the threads are clean and the fittings are free of corrosion. Replace as necessary. Install the fitting in the cylinder head inlet port, positioning it in the proper orientation. Tighten the jam nut to 597–655 in-lbs (67–74 Nm).

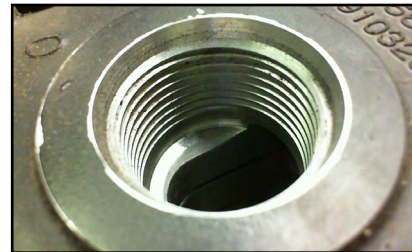
INLET PORT THREADS ARE
IN GOOD CONDITION
