Technical Bulletin

Bulletin No.: PRO-20-07

Subject: **Ford F Series Truck Hydraulic Parking System HR-1 Hydraulic Relay Noise**

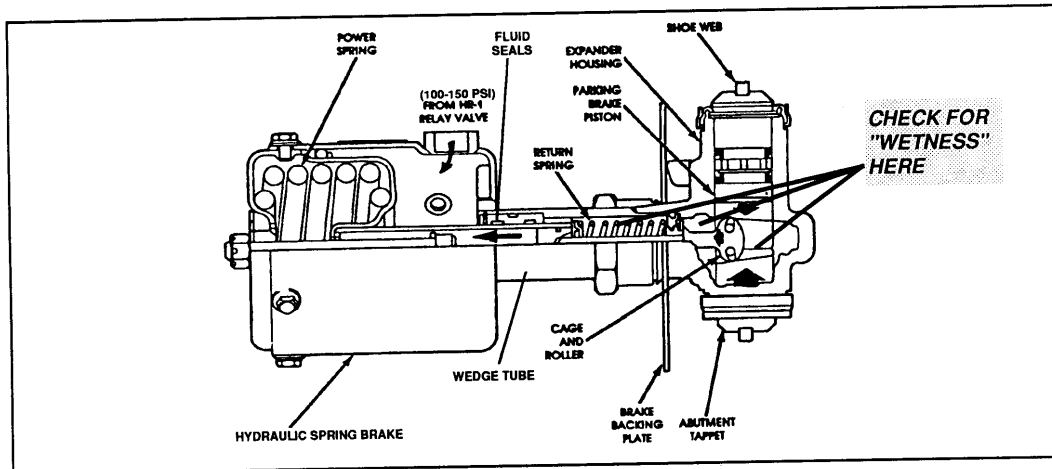
PARKING ACTUATOR WITH LUCAS GIRLING EXPANDER

Most fluid leaks can be found by visual inspection, however the spring brake actuators can LEAK INTERNALLY INTO THE EXPANDER unit of the Lucas Girling A2LS drum brake. Internal, hydraulic spring brake leakage can not be detected visually unless the actuator is removed from the expander and checked for "wetness" inside the wedge tube.

Both actuators should be checked for internal leakage. If evidence of internal leakage is found in either of the actuators, it may be necessary to repair or replace all components containing BRAKE FLUID SEALS, that may have been exposed to hydraulic fluid from the leaking spring brake actuator. The affected components are the: A2LS expander unit, A2LS wheel cylinder and possibly the master cylinder. Drain, flush and replace the brake fluid in the service brake system to eliminate any hydraulic fluid contamination.
