**Subject: Bendix® TABS-6™ Advanced Single-Channel Trailer ABS: Troubleshooting
“Internal Lateral Acceleration Sensor - Mounting Error” Diagnostic Trouble Codes**

The purpose of this Bulletin is to assist technicians when troubleshooting Bendix® TABS-6™ Advanced single-channel trailer ABS modules, where an “Internal Lateral Acceleration Sensor - Mounting Error” (internal code 14D00, or SID-FMI 99-14, or blink code 8-1), is causing an illuminated trailer ABS lamp.

P/Ns K027233, K029053, K027235, K032041, K032042, K027241, K035805, K032108, K041383, and K065528.

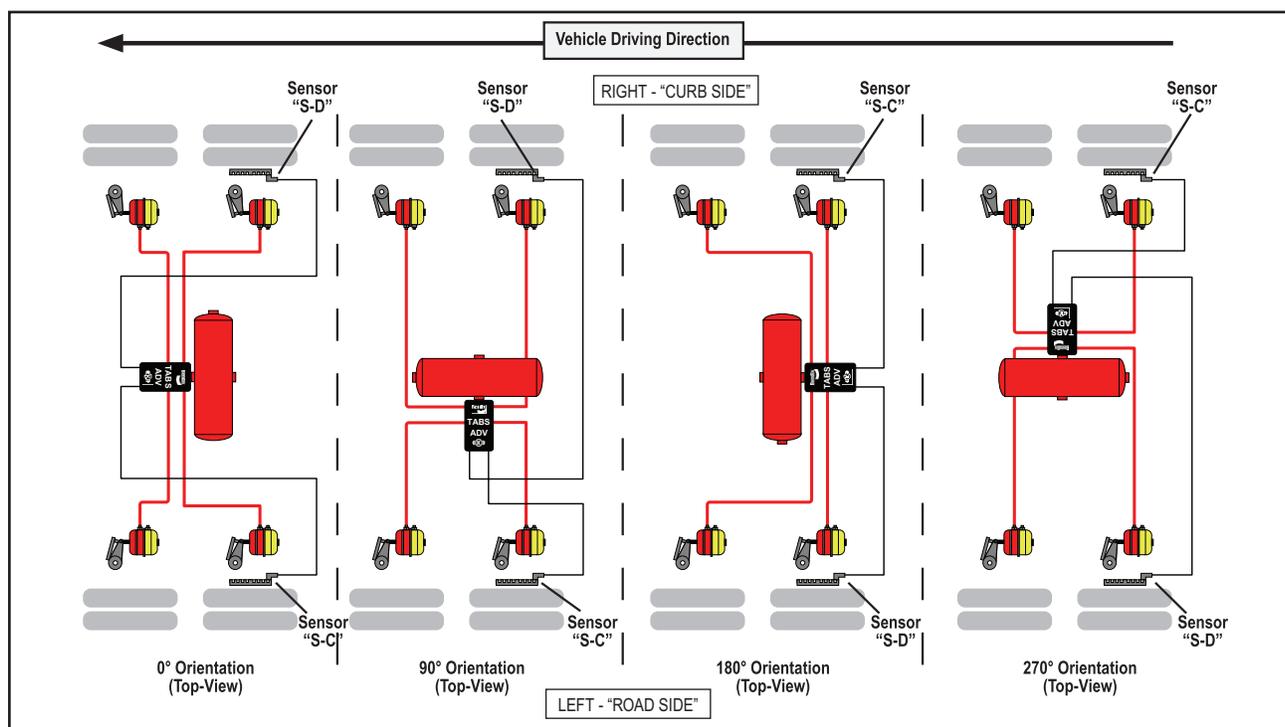
FIGURE 1 - BENDIX® TABS-6™ ADV MODULE ORIENTATION & WHEEL SPEED SENSOR LOCATIONS

B. Check if the wheel speed sensors ‘SC’ and ‘SD’ are swapped

This DTC is caused by the ECU comparing the difference in wheel speed readings between the left and right wheel speed sensors to cross-check with the on-board lateral accelerometer. Reversed sensors can cause a DTC to falsely trigger. Wheel speed sensors ‘SC’ and ‘SD’ locations are ECU-orientation specific (See Figure 1).

- change the configured orientation to match the installation;
- verify that the speed sensors are installed correctly for this configured orientation (see Figure 1); and
- perform an End-of-Line Test (EOL Test) using the software or a Bendix® Trailer Information Module™.

Make any needed changes, and then use the Bendix® ACom® Diagnostics software to run the Bendix® TABS-6™ Advanced End-of-Line Test (EOL Test) and recheck for any other remaining DTCs before returning the vehicle to service.
