Technical Bulletin

Bulletin No: TCH-013-007

Subject: **Bendix® EC-30T™ ECU Product Recall Campaign**

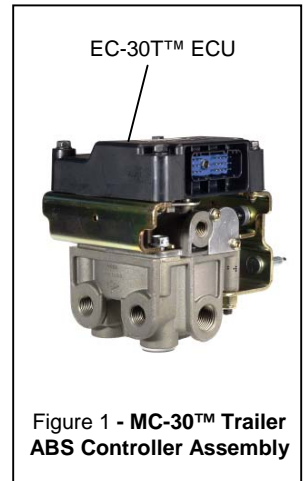
The EC-30T can be identified by the black plastic enclosure imprinted with the Bendix® logo, and containing a single 30-pin connector and an LED diagnostic display.
