Technical Bulletin

Bulletin No: TCH-002-014

Subject: **Bendix® Air Disc Brake Actuator Vent Hole Orientation**

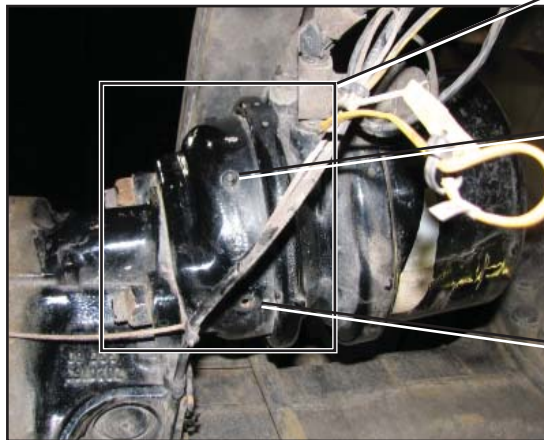
Air Disc Brake Actuator - Bottom View Shown

It has come to our attention that some Bendix® brand air disc brake actuators in service have the bottom vent hole plugged in error. This allows moisture and contaminants to enter, but not drain, causing corrosion and premature failure of the actuator.

Plugged Vent
(All other vent
holes may be
open or closed)

Open Vent
(Bottom vent hole
must be open)

Action: Vehicles with Bendix® brand air disc brake actuators should be inspected to verify that the vent hole closest to the bottom of the actuator is open. If a plug is found in this location, it must be removed to allow proper draining. The removed plug can be discarded. It is not necessary to place it in the other open port. Removal of the plug is easily completed by pulling it out with a pair of needle nose pliers. Note that the removal of this plug will not impact the actuator warranty.
