Technical Bulletin

Bulletin No: TCH-003-052

Subject: Excessive Wear of E-7™ Brake Pedal Components

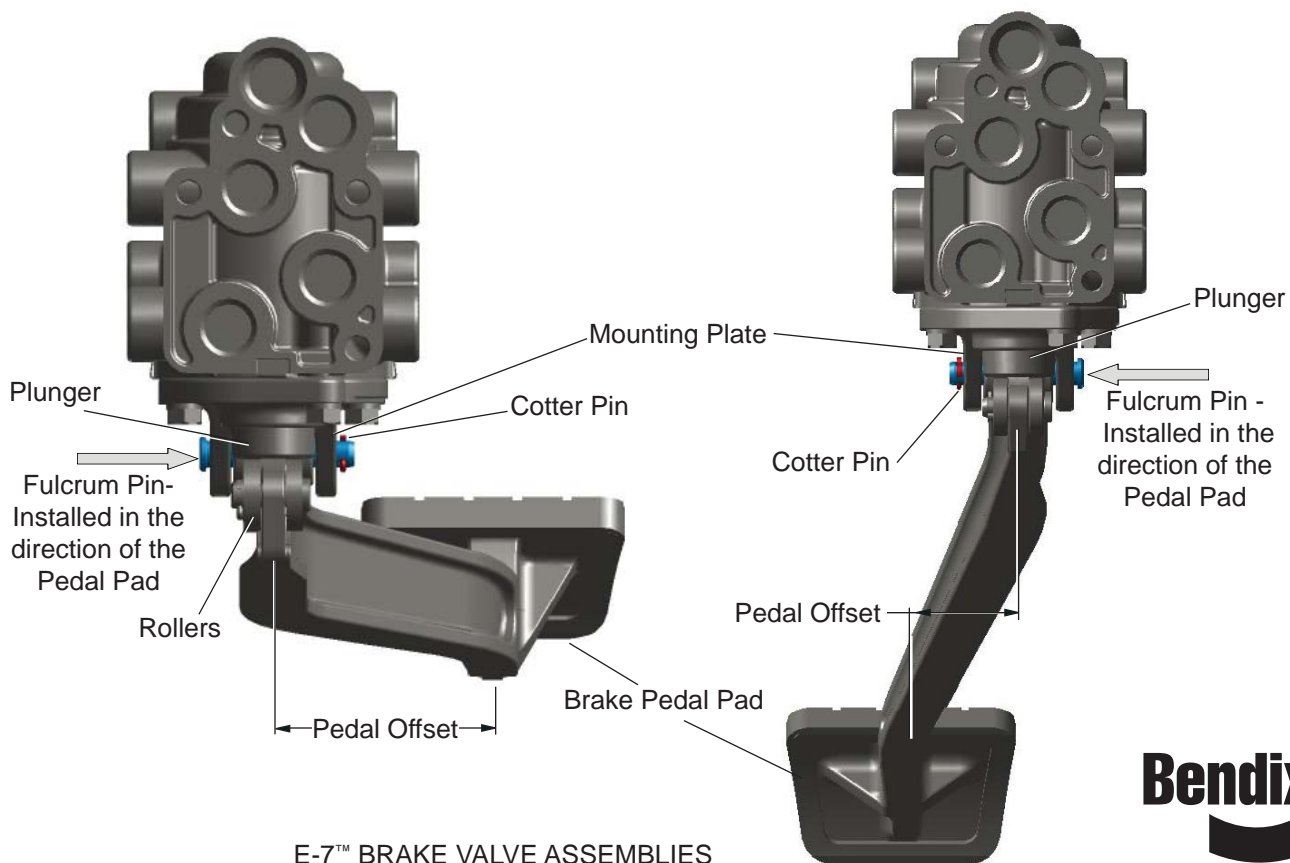
On high-offset pedal applications, the cotter pin that retains the fulcrum pin can become damaged. This can be identified by wear marks on the side of the mounting plate. To maximize the life of the cotter pin, the fulcrum pin should be installed such that the cotter pin is located on the same side of the mounting plate as the brake pedal pad. See illustrations below.

Inspect the pedal to see that all cotter pins, rollers, roller pins and fulcrum pins are in place. Excessively worn, damaged or missing components should be replaced before operating the vehicle. To identify if the pedal components are excessively worn, grab the pedal at the foot pad and push side to side. If the pedal has movement over .250 inches then the pedal, mounting plate, and fulcrum pin, should be replaced.

Other signs of wear that will require inspection are deterioration of the boot, plunger wear, and wear in the mounting plate at the fulcrum pin holes. If the wear is excessive, the fulcrum pin holes become oval in shape. The plunger bore and fulcrum pin holes should always be liberally coated with barium grease. These parts may require more frequent lubrication if the vehicle's interior is regularly pressure washed as part of a maintenance program.
