Action Required For Identifying the Recalled Bendix® TR-3™ Valve

Identifying TR-3 valves covered in this field action

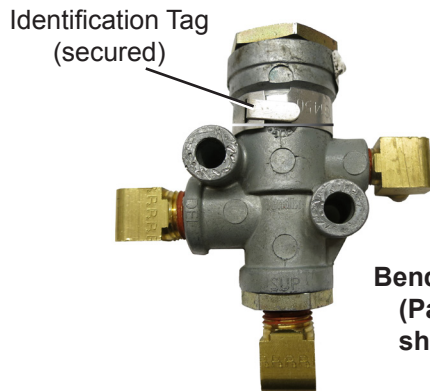
Bendix® TR-3™ Valve
(Part No. 101450
shown on valve)

To verify that the Bendix® TR-3™ valve (P/N 101450 displayed on the valve) has been replaced per the recall campaign, look for the presence of a green cable tie secured to the valve body.
No further action is required.

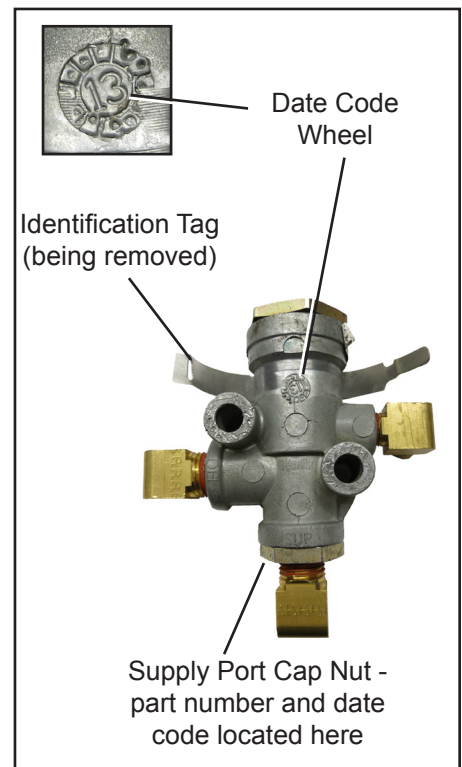
A date code is stamped (not cast) on the TR-3 valve supply port cap nut. *Locate the date code – removing the paint coating, if necessary – to read the code.*

- The first field is the month (A=January, B=February, etc. – excluding the letter I – so that J=September, and so on).
- The next two fields are the date (e.g. 06=6th day of the month)
- The next two fields are the year (e.g. 14=2014).
- The final code in the sequence is the Plant Code (T for all valves in this campaign)

February 6, 2014 through October 15, 2014
That is, B0614T through K1514T

Action required. Contact your OEM dealer to schedule the replacement of your TR-3 valve.
