Part Number Update

Subject: Bendix® ACom® Diagnostic Software - Mandatory Update

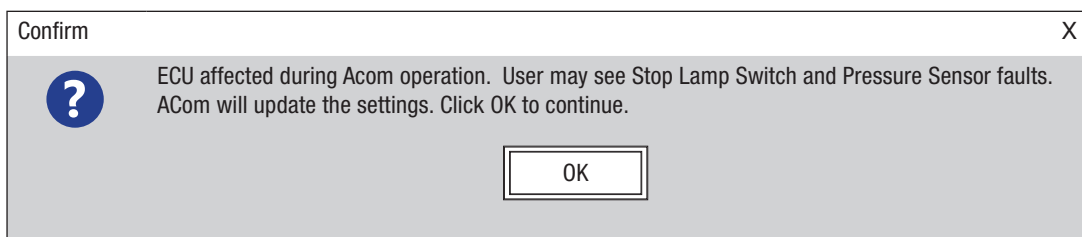
Bendix® ACom® diagnostic software v6.16.5.2 is now released and available for download on Bendix.com. The earlier release, ACom software v6.16.5.0, has been removed from the Bendix website and should not be used as it may result in erroneous Diagnostic Trouble Codes (DTCs) on Bendix® ESP® Stability EC-80™ Electronic Control Unit (ECU). The new Bendix ACom software is available on bendix.com and must be used for troubleshooting.

If the DTCs shown in the table below were observed and continue to recur after connecting ACom diagnostic software v6.16.5.0 to a Bendix ESP Stability EC-80 ECU, then ACom diagnostic software v6.16.5.2 or greater must be used to clear the DTCs.
