Technical Bulletin

Bulletin No.: PRO-20-07

Subject: **Ford F Series Truck Hydraulic Parking System HR-1 Hydraulic Relay Noise**

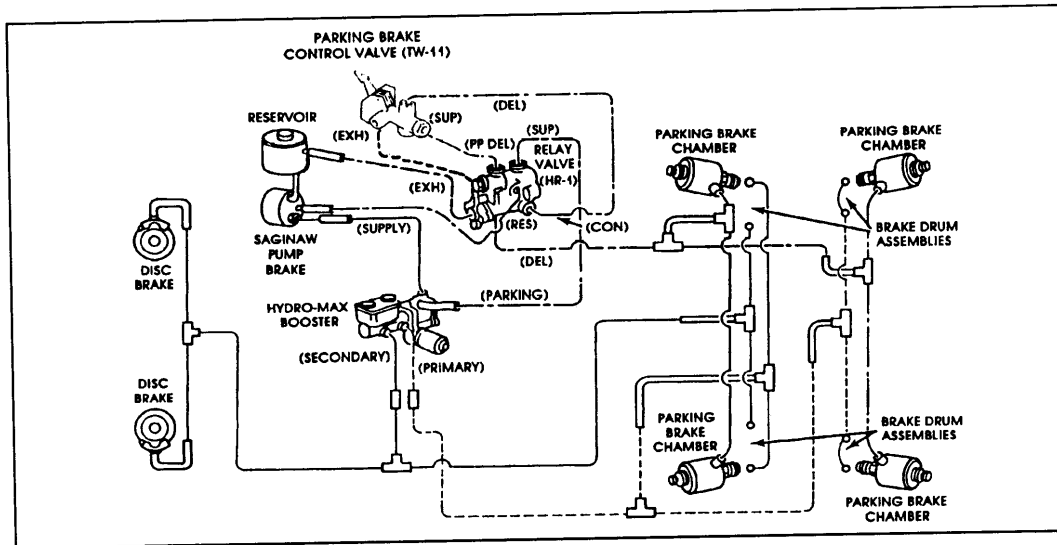
TYPICAL HR-1 SYSTEM

While some noise is inherent in the operation of a hydraulic brake system (pump, check valves and pressure regulating valves opening and closing) operators occasionally report hearing excessive noise emanating from the HR-1 hydraulic relay valve. The HR-1 is used on Ford truck model series 600, 700, 800, 900, 7000 and 8000. Described variously as a "buzzing, humming, popping or groaning" sound, the excessive noise is often attributed to a faulty HR-1. Because the HR-1 is mounted on the firewall, adjacent to the Hydro-Max booster, sounds are amplified. Excessive HR-1 noise can be the result of air in the parking brake system.

In order to eliminate the excessive HR-1 noise it is necessary to bleed the air from the spring brake actuators, using the vehicle manufacturer's recommended procedure. If the HR-1 noise is only temporarily eliminated and reappears in a short period of time, then it is likely that an external leak exists somewhere in the Hydro-Max and/or parking brake system which allows air to reenter the system. Check for fluid leakage and repair or replace as necessary.

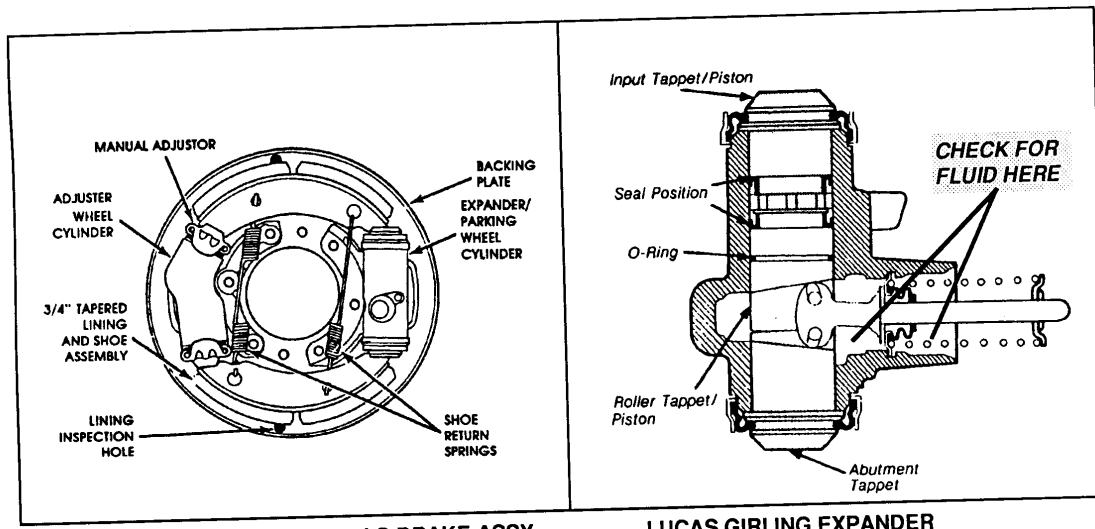
Most fluid leaks can be found by visual inspection, however the spring brake actuators can LEAK INTERNALLY INTO THE EXPANDER unit of the Lucas Girling A2LS drum brake. Internal, hydraulic spring brake leakage can not be detected visually unless the actuator is removed from the expander and checked for "wetness" inside the wedge tube.

Both actuators should be checked for internal leakage. If evidence of internal leakage is found in either of the actuators, it may be necessary to repair or replace all components containing BRAKE FLUID SEALS, that may have been exposed to hydraulic fluid from the leaking spring brake actuator. The affected components are the: A2LS expander unit, A2LS wheel cylinder and possibly the master cylinder. Drain, flush and replace the brake fluid in the service brake system to eliminate any hydraulic fluid contamination.
