**Subject: Bendix® TABS-6™ Advanced Single-Channel Trailer ABS: Troubleshooting
“Internal Lateral Acceleration Sensor - Mounting Error” Diagnostic Trouble Codes**

The purpose of this Bulletin is to assist technicians when troubleshooting Bendix® TABS-6™ Advanced single-channel trailer ABS modules, where an “Internal Lateral Acceleration Sensor - Mounting Error” (internal code 14D00, or SID-FMI 99-14, or blink code 8-1), is causing an illuminated trailer ABS lamp.

P/Ns K027233, K029053, K027235, K032041, K032042, K027241, K035805, K032108, K041383, and K065528.

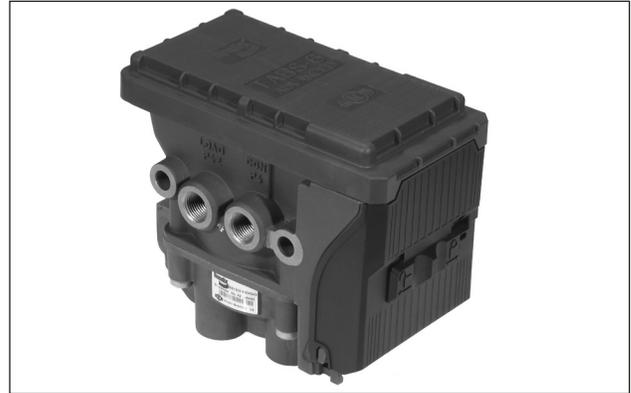
FIGURE 2 - TABS-6 ADVANCED SINGLE-CHANNEL MODULE (TABS-6 ADV)

The TABS-6 Advanced cross checks the on-board lateral acceleration sensor reading with a lateral acceleration calculated value based on vehicle track width, programmed orientation and wheel speed sensor differences (left to right). If the two values do not correspond to each other within predefined limits the lateral Diagnostic Trouble Code is set. Any of the items used to calculate lateral acceleration (speed sensor readings, programmed track width and programmed orientation) if incorrect can cause a false detection of this DTC.
