Installation Instructions

Bendix® TABS-6™
Trailer ABS
Reconfiguration Kit

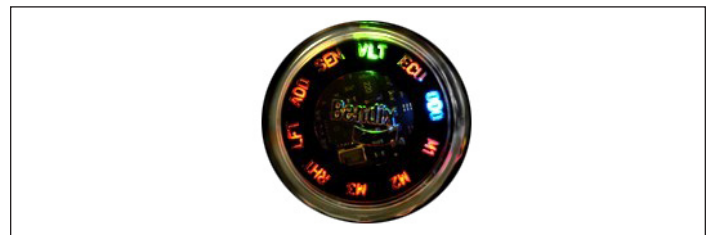
If the configuration was unsuccessful, the special TRDU will leave all LED's illuminated until the TRDU is removed from the diagnostic connector.

FIGURE 3 - UNSUCCESSFUL CONFIGURATION

If the configuration was unsuccessful, check to verify that:

The ABS ECU is the correct part number (a Bendix TABS-6 Standard or Premium). If the green VLT LED flashes 4 times and then all the LEDs illuminate, the part number of the Bendix TABS-6 ECU is incompatible with the function of this tool.

The tool will also indicate if it can not establish communications with the TABS-6 ECU by leaving the green VLT LED illuminated solidly upon power up, then illuminate all the LEDs similar to an unsuccessful configuration (in a clock-wise pattern) until the TRDU is removed from the diagnostic connector.
