Make sure you're getting the real thing, look for the "Genuine Bendix"

Comprehensive testing by Bendix Commercial Vehicle Systems has shown knock-off air dryers, as compared to the industry leading Bendix® AD-9® air dryer, not only fall short of Bendix specifications, but can lead to unintended consequences on braking performance and stopping ability and damage to other components in the air brake system.

The facts speak for themselves... take a closer look

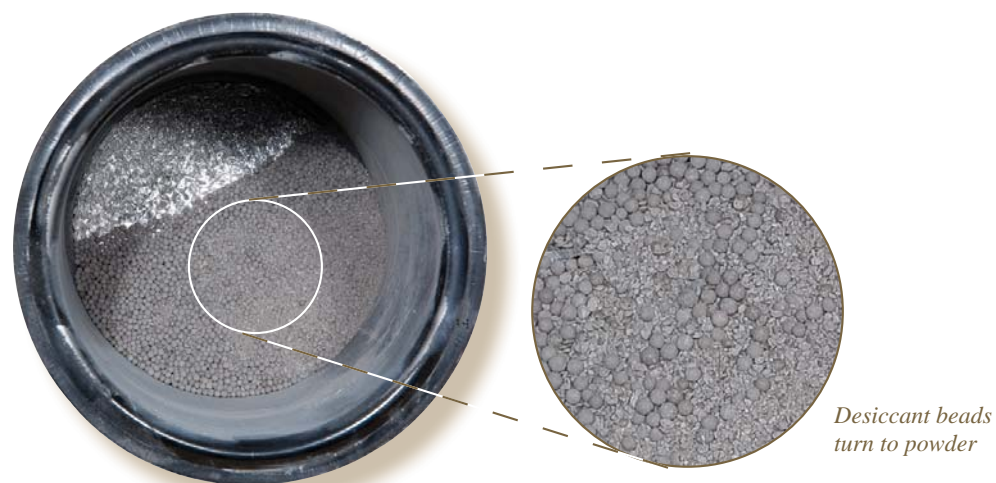
Knock-off Cartridge After Operating Durability

The Issue: Powdered and Oil Soaked Desiccant

The Impact: Contamination leading to downstream component malfunction or failure

Inferior desiccant delivered 35% less drying capacity and was easily fouled by oil, reducing dryer life by 50%. In addition, the desiccant beads turned to powder, traveling downstream.

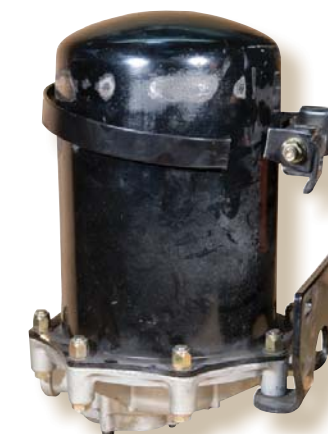
Knock-off Dryer After Vibration Resistance

The Issue: Broken Mounting Bracket

The Impact: Air dryer may separate from vehicle frame

A broken bracket can lead to air dryer damage.

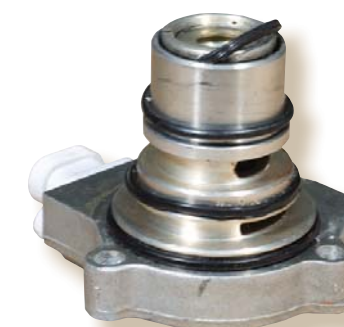
Knock-off Purge Valve High Temperature Durability

The Issue: Purge Valve Came Apart

The Impact: Unable to build air – vehicle down

Purge valve assembly bolt became loose during testing, causing a massive air leak. The leak was more than the compressor output. The knock-off failed after only 30% of the test was completed.
