# Technical Bulletin

Bulletin No: TCH-023-007

## subject: Potential Brake Pad Fitment Issue on Bendix® ADB22X® Air Disc Brakes

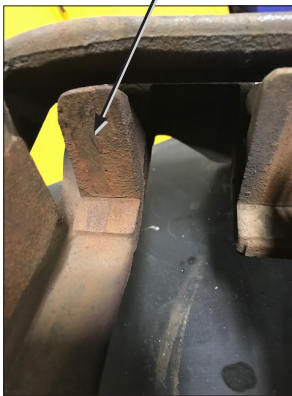
It has come to our attention that some Bendix® ADB22X® Air Disc Brake customers have experienced issues fitting pads into the brake carrier.

Bendix® Brake Pad

Abutment Surface Rust

1. Assess the brake pad fitment within the brake carrier.
2. If the brake pads do not have adequate clearance, remove the pads and clean the abutment surface on the carrier with a flat file. **Do not use power tools.** Remove an even amount of material from the entire surface. Wipe clean. See illustrations below.

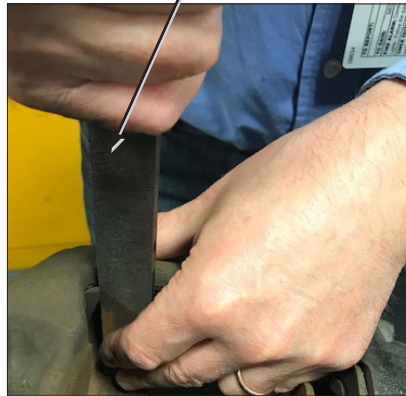
Filing the  
Abutment Surface

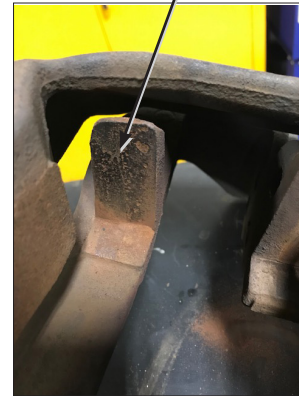
Abutment Surface  
Rust Removed

3. Insert the pads into the carrier and reassess the fitment.
4. If the pads do not slide freely into the carrier, repeat Steps 2 and 3. Note: Remove only the amount of material necessary to allow the pads to move freely.
5. If the pads still do not fit, swap the positions of the inboard and outboard pads.
6. Contact your Bendix representative or the Bendix Tech Team at 1-800-AIR-BRAKE (1-800-247-2725), option 2, for further assistance. Representatives are available Monday through Thursday 8:00 am - 6:00 pm and Friday 8:00 am - 5:00 pm. You can also reach the Tech Team by email at [techteam@bendix.com](mailto:techteam@bendix.com).
