Sheppard[™] Steering Gears

RHS0007 Initial Release Date: 7/1/22 Revision Date: 3/15/24

Identifying Sheppard™ Steering Gears Covered in Field Actions

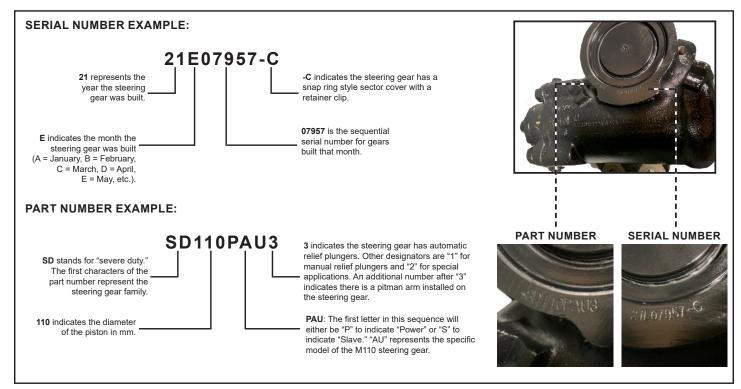
Figure 4 - Serial Number and Part Number Interpretation

A serial number and part number are engraved into the steering gear housing. See Figure 4 for further information on interpreting the serial number and part number.

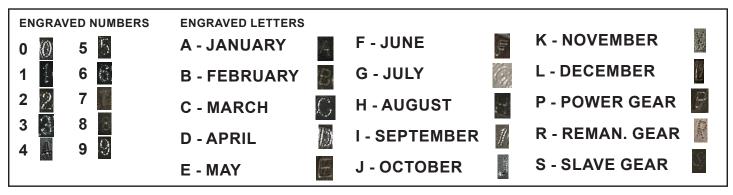
Figure 5 - Engraved Numbers and Letters

See Figure 5 for representations of each number (year) and letter (month) for steering gear serial numbers.
